# *RE-ENGINEERING WAY FORWARD OF VALUE MANAGEMENT IN EXISITING LARGE DIA OF SEWER NETWORKS REPLACEMENT - A S.O.E (State Own Enterprise) PROJECT – Cyber Valley, Selangor, MALAYSIA.*

By: Mohd Syazwan; *Phd,MBA,MSc.BSc*

DRMGS IIAM PAPER ICUMAS 2018  
*Regional Director of Asia & President Malaysian Chapter.*

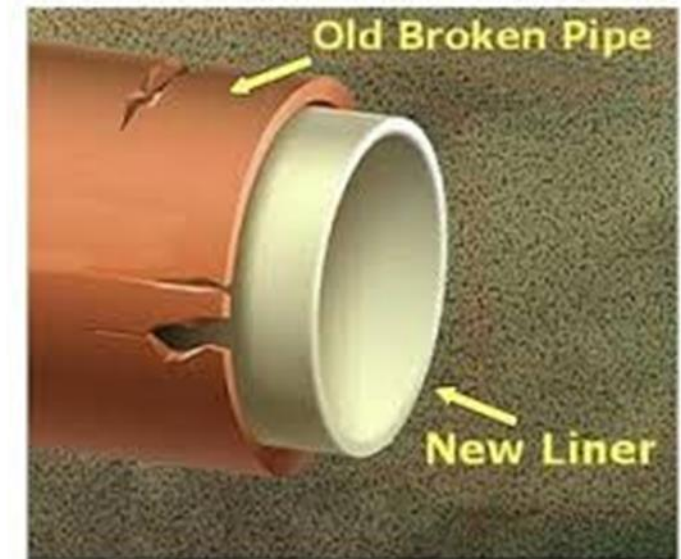
Typical Sewer Defects

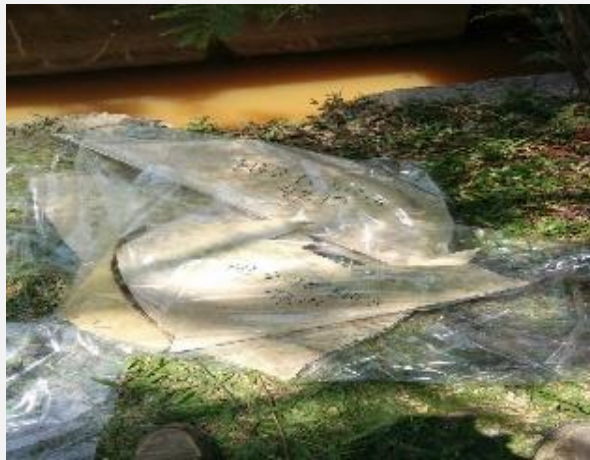
MHBI3-2 TO MHBI3-3,  
47.15 m

Removed defective patches. Sampling and tagging.

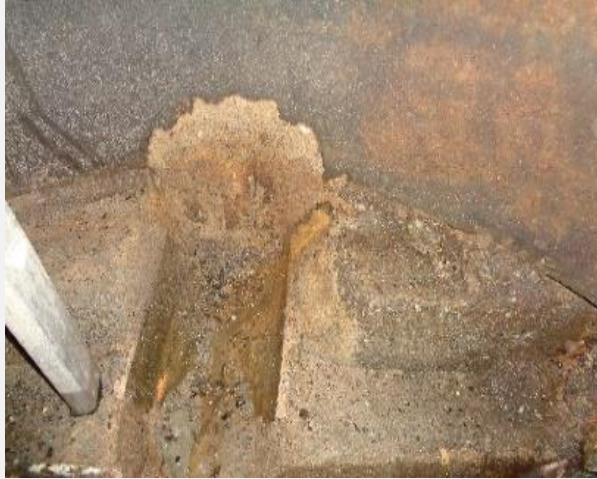
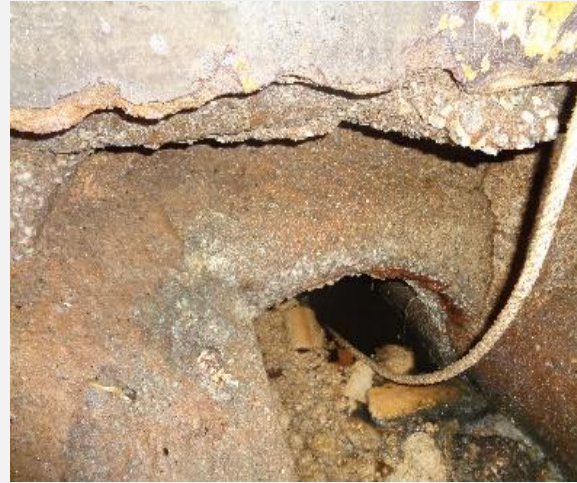
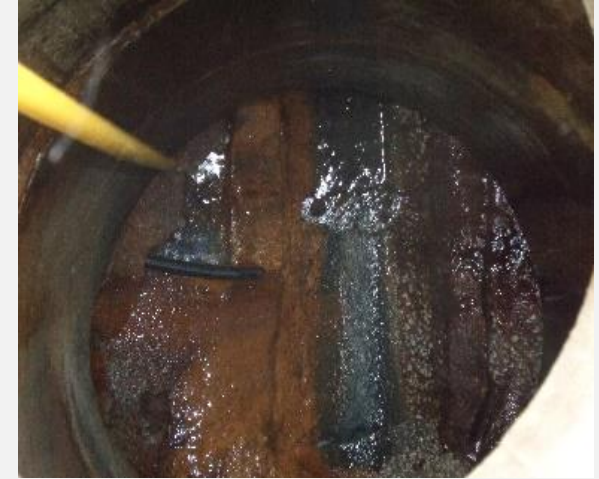
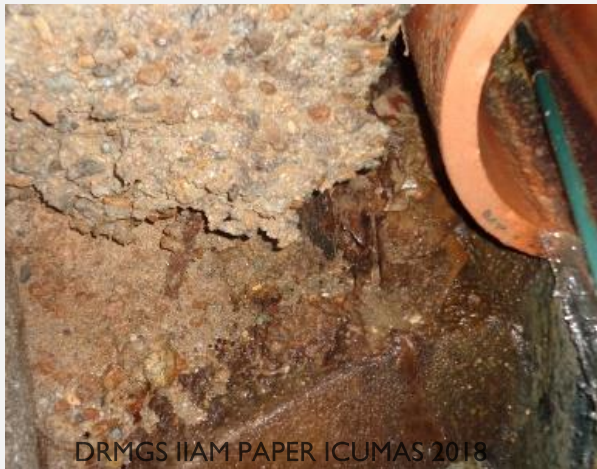
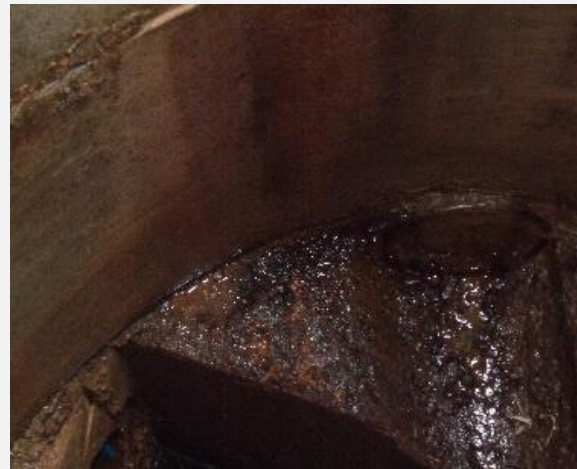
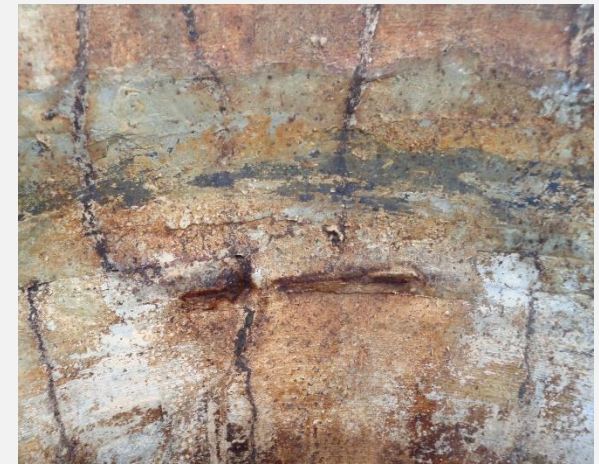
- Leaking & crack of manholes

No	Description	Rehabilitation works	Quantity
1	Sealing of leaking existing manholes	Sealing of leaking manholes with approved urethane base polymer gel or equivalent all in accordance with specification.	13
2	Rehabilitation works to manhole (walls, slabs and benching)	The works shall include grouting, coating, plastering, replacing of damaged or missing item such as bricks of manholes.	22
3	Application of epoxy resin mortar (HAC resin mortar)	Allow for applying 5mm thick HAC resin mortar or equivalent for against hydrogen sulphide corrosion to manhole walls, slabs and benching as per specification. Please refer Appendix A for further information.	42
4	Upgrading of existing manhole barrel  DRMGS IIAM PAPER ICUMAS 2018	Allow for provision upgrading of existing manhole barrel of 1200mm internal dimension to the following sizes in accordance to SPAN MSIG Vol 3 Standard. Please refer Appendix B for further information.	14

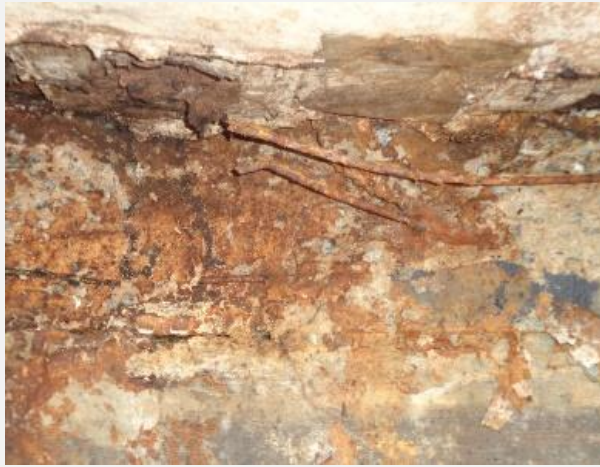
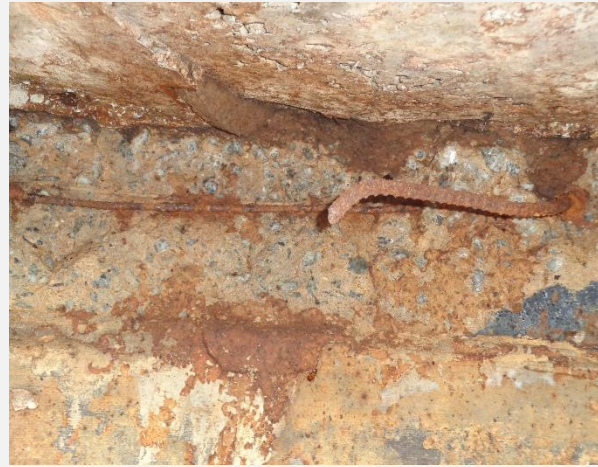
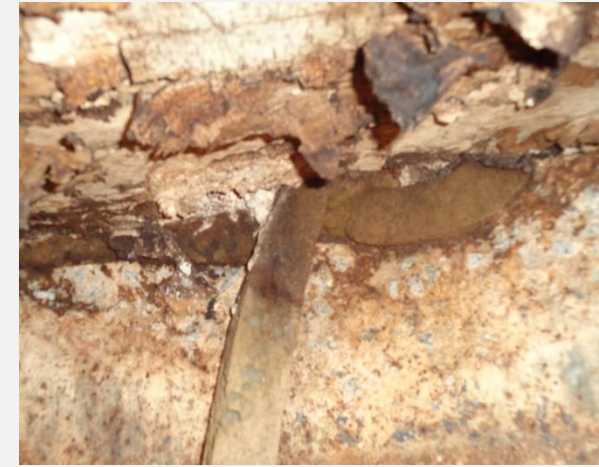
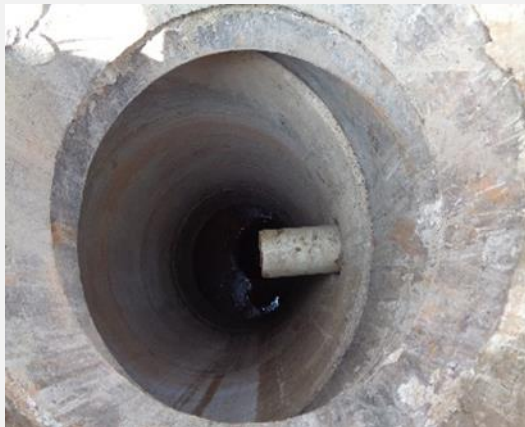
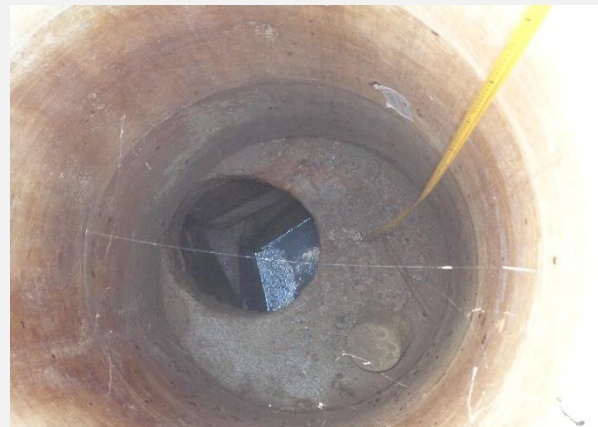
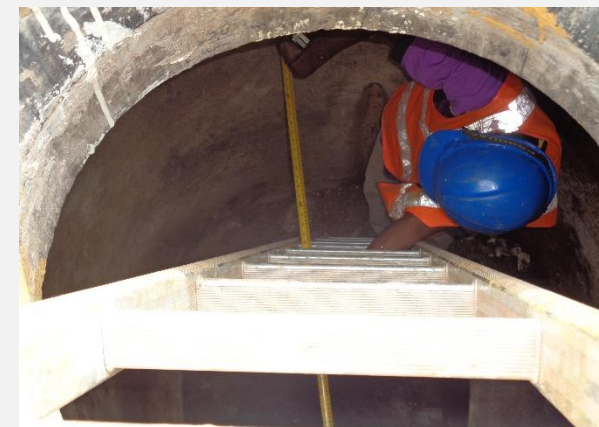
- Visible reinforcement below RC slab & Minimum internal dimension
