# *RE-ENGINEERING WAY FORWARD OF VALUE MANAGEMENT IN EXISITING LARGE DIA OF SEWER NETWORKS REPLACEMENT - A S.O.E (State Own Enterprise) PROJECT – Cyber Valley, Selangor, MALAYSIA.*

By: Mohd Syazwan; *Phd,MBA,MSc.BSc*

DRMGS IIAM PAPER ICUMAS 2018  
*Regional Director of Asia & President Malaysian Chapter.*

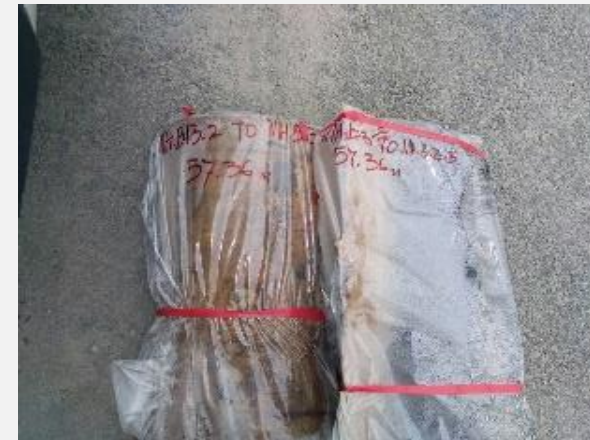
MHBI3-2 TO MHBI3-3,  
50.4 m

Removed defective patches. Sampling and tagging.
